DISASTER MANAGEMENT IN BANGLADESH: AN ARCHITECT'S INVOLVEMENT

B Haq, Bashirul Haq and Associates Ltd., Bangladesh

BATTLING THE STORM- STUDY ON CYCLONE RESISTANT HOUSING by Community Based Disaster Preparedness Programme, Bangladesh Red Crescent Society / German Red Cross. Published by German Red Cross (A Registered Project of the world exposition, Germany)

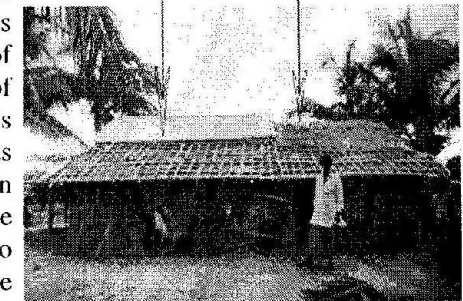
HOUSE OF MONIR HPSSAIN AT CHAR PARA, MOHESHKHALI

Original corrugated metal roof of BDRCS'S house type.

Thatch roof added later.

The photograph of the house on this page shows the transformation of a BDRCS initiated house type. The roof of the BDRCS house type is visible within the present house form shaped by addition and alteration in order to suit the life style of the beneficiary, Munir Hussain at Charpara, Moheshkhali.

hip roof; and because of this separation, roof of pashchati usually suffers wind damage without affecting the roof of the 'ghar'. Pashchati area, beside creating extra space for entertaining of guest eating, cooking sleeping etc., also acts as a barrier during cyclone accompanied by heavy rain. Further, its low roof creates a sense of protection.

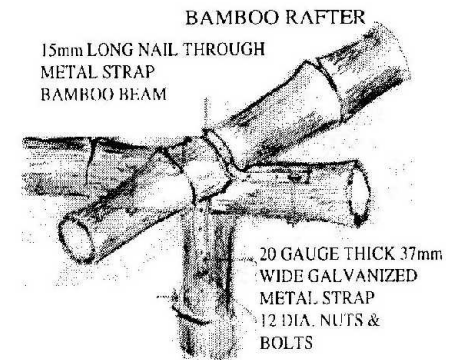
The roof structure consists of horizontal bamboo support members (beams) supported by bamboo posts. The bamboo beams support the rafters of split bamboo. In the roof structure system, the most important connections are the connection between beams and vertical support and the connection between rafters and beams. In order to make houses cyclone resistant, these connections should be strong in order to withstand the strong upward force of

the cyclone. Metal straps, commonly known as hurricane straps in hurricane prone countries, may be used in the connections, particularly for connections between post and beam. The local technology for connection details between beam and rafter is done by tying the rafter firmly to the beam by nylon rope after cutting a notch or 'housing' in the rafter and in a better constructed structure the notch in the rafter is securely fitted to the beam maintaining the required slope at the same time. In terms of cyclone resistance we recommend the use of 20 gauge galvanized metal strap, nails, nuts and bolts along with the use of traditional materials like nylon rope etc.

FIXING DETAILS BETWEEN POST, BEAM & RAFTER
